Manhole Inspection Summary

Manhole # S23E1_001MH

Insp Date: **7/22/08 2:18 PM**

Location Address: **2605 Puget St**

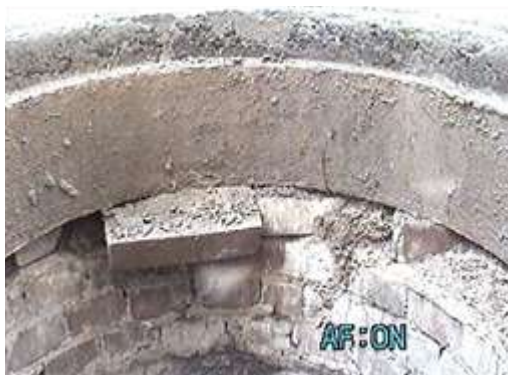
Defect 2

Condition: ☐ Sound ☐ Cracked ☐ Root Intrusion ☒ **Loose Brick** ☐ Deteriorated

Infiltration: ☐ None ☒ **Joint** ☐ Cracks ☐ Mortar ☐ Roots ☒ **Wall**

loose brick, infiltration lid-frame-chimney

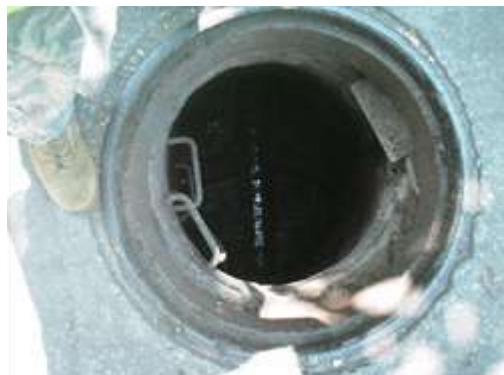
Defect 3

Frame Offset: **2** (in.) Condition: ☐ Sound ☐ Cracked ☒ **Leaks**

offset frame 2"

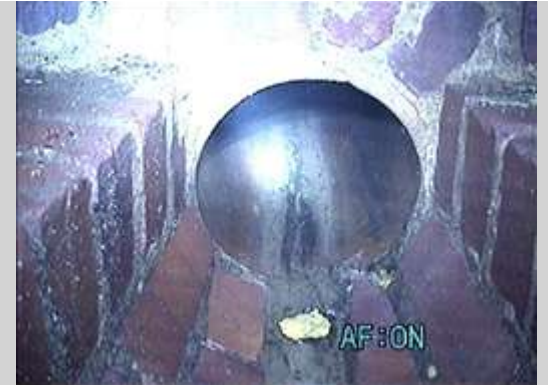
12 O'Clock Outflow

8 in. Circular Gravity Sewer
Pipe Out @ 12 O'Clock

Pipe Height: **8.4** (in.) Rod and Bar (Angled)
Pipe Material: **Clay** ☐ Pipe Lined
Invert Depth: **9.69** (ft.) Flow Characteristics: **Fast**
Deposits: ☒ None ☐ Mud ☐ Sludge ☐ Debris ☐ Grease
Silt Depth: **0** (in.) Deposits Extent:
Infiltration: **None** Pipe Seal Cond: **Sound**

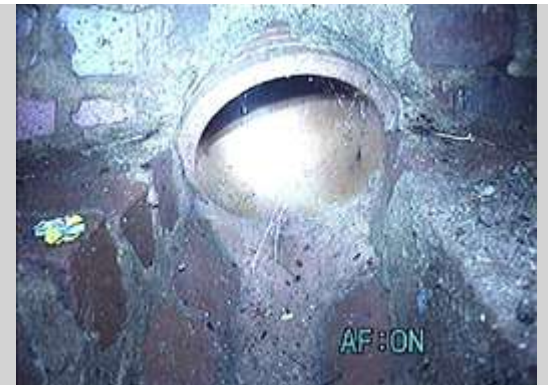
3 O'Clock Inflow

8 in. Circular Gravity Sewer
Pipe In @ 3 O'Clock

Pipe Height: **7.2** (in.) Rod and Bar (Angled)
Pipe Material: **Clay** ☐ Pipe Lined
Invert Depth: **9.01** (ft.) Flow Characteristics: **None**
Deposits: ☒ None ☐ Mud ☐ Sludge ☐ Debris ☐ Grease
Silt Depth: **0** (in.) Deposits Extent:
Infiltration: **None** Pipe Seal Cond: **Sound**

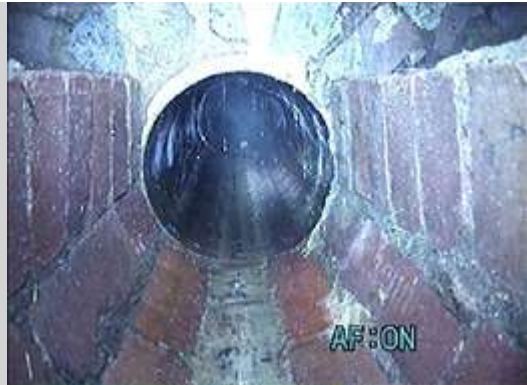
6 O'Clock Inflow

Pipe Height: **8.4** (in.) Rod and Bar (Angled)

Infiltration: **None** Pipe Seal Cond: **Sound**

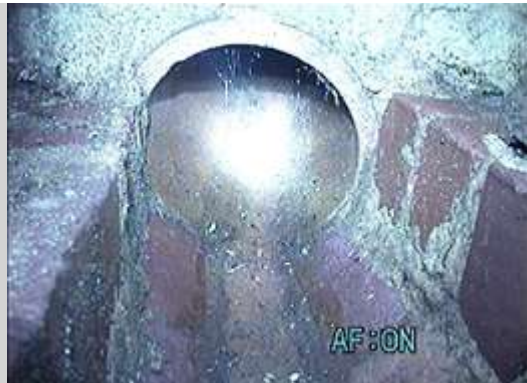
9 O'Clock Inflow

Pipe Height: **8.4** (in.) Rod and Bar (Angled)

Infiltration: **None** Pipe Seal Cond: **Sound**
